ELECTRO-OPTICAL CABLE FOR USE IN TRANSMISSION OF HIGH VOLTAGE
AND OPTICAL SIGNALS UNDER EXTREMES OF TEMPERATURE AND
ALTITUDE

Tow/Signal Line Development

Phase C Thermal Upgrade Towline Flight Test Review

TDM033 Assessment

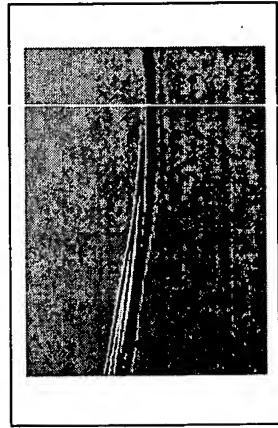
Signal pitch around tow very loose

- Light Abrasion of Signal Line Through-out
- Zylon Color Normal
- No heat induced damage visible
- Electric continuity throughout (except 14 inches from decoy end)
